SEASONAL MONITORING PROGRAM DISMANTLE REPORT SITE 041024, FLAGSTAFF, ARIZONA.

January 1997

Suspension of SMP Site Monitoring Activities, Site 041024

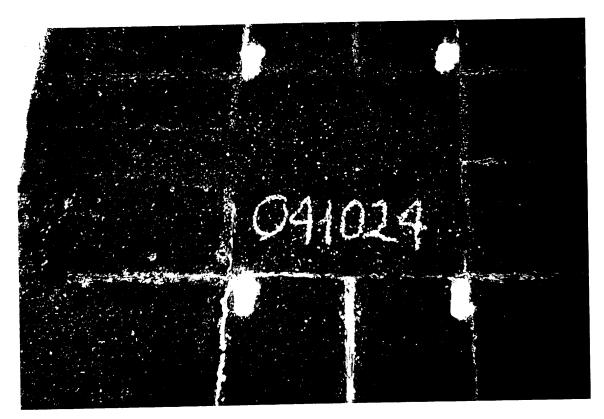
Instrumentation Hole.

- The instrumentation hole and access trench were both closely inspected and the joints were sealed with silicone sealant wherever necessary. No patching was required.

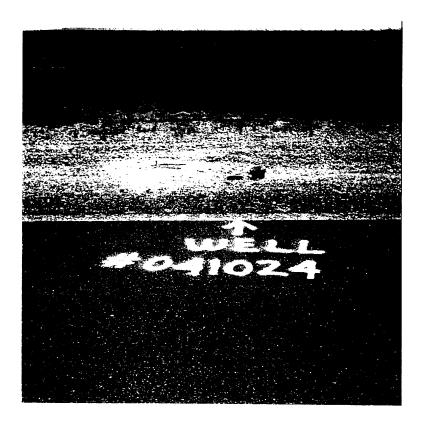
Observation Piezometer.

• The observation well and cap threads were thoroughly cleaned and lubricated

(greased) before the well was sealed.

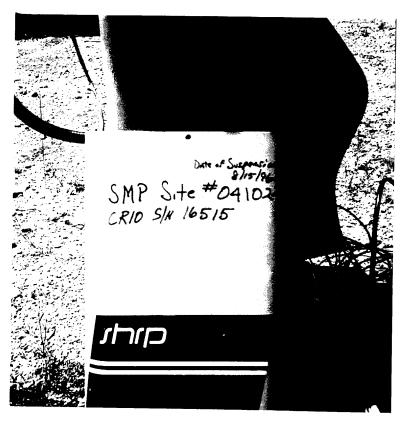
Equipment Cabinet.

- The instrument panel board containing the CR10 datalogger, the relay and the terminal strip was removed.
- The equipment cabinet was checked and adequate drainage was ensured in case of heavy precipitation.

- The equipment cabinet lock was lubricated with graphite lubricant, the lock was taped to keep out the natural elements.
- Nails were driven into the pavement at the elevation measurement and FWD test locations, the nailheads were spray painted white for easy identification
